TAN BURRUP PROJECT	02080

Annual Environmental Compliance Report February 2013/February 2014	PAGE 1 OF 127	
	2-250-329-REP-TRE-8055	REV.: 00

Annual Environmental Compliance Report February 2013/February 2014

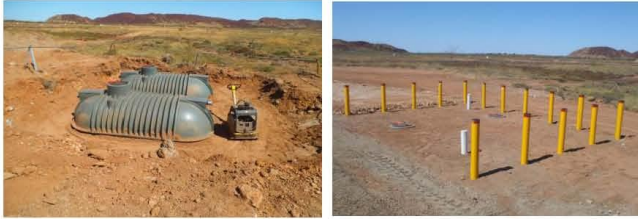
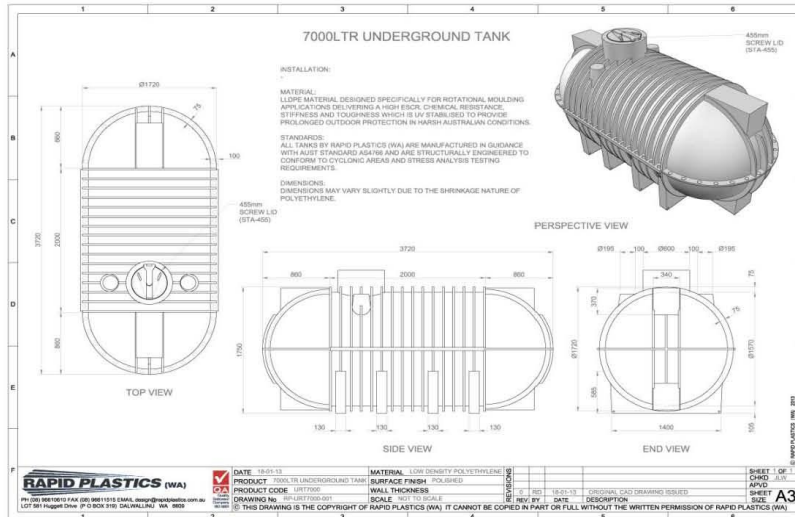
7000 LTR underground tanks at Técnicas Reunidas' offices.

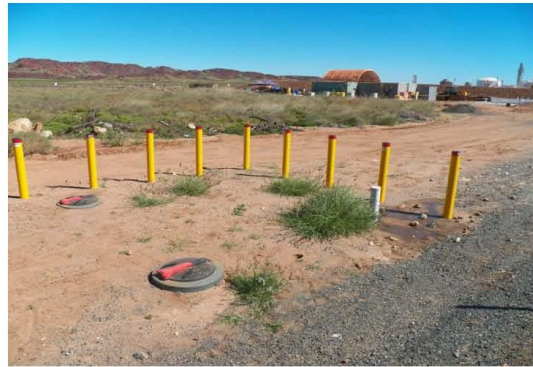
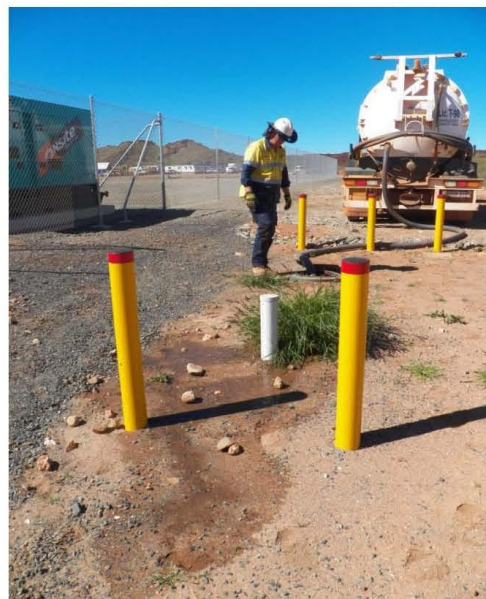
Picture of Sanitary wastewater spill

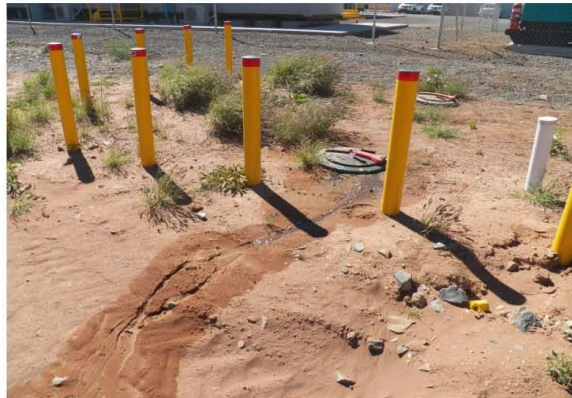
Picture of Sanitary wastewater spill

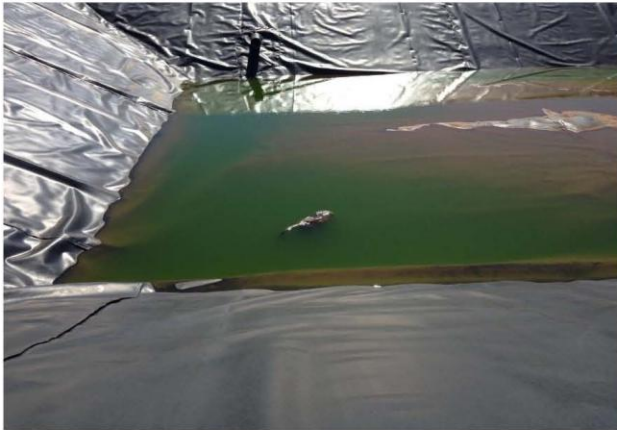
Kangaroo floating in pond
